COMMONWEALTH OF KENTUCKY  
BEFORE THE PUBLIC SERVICE COMMISSION

LOUISVILLE GAS AND ELECTRIC COMPANY)	)	
_____	)	CASE NO. 98-592
	)	
ALLEGED FAILURE PURSUANT TO	)	
807 KAR 5:041, SECTION 3, TO COMPLY	)	
WITH NATIONAL ELECTRIC SAFETY CODE	)	
("NESC"), 1990 EDITION, SECTION 23,	)	
CLEARANCES, RULE 234 B, 1&2	)

**AN APPENDIX TO AN ORDER OF THE KENTUCKY PUBLIC SERVICE  
COMMISSION IN CASE NO. 98-592 DATED NOVEMBER 20, 1998.**

**UTILITY ACCIDENT  
INVESTIGATION REPORT**

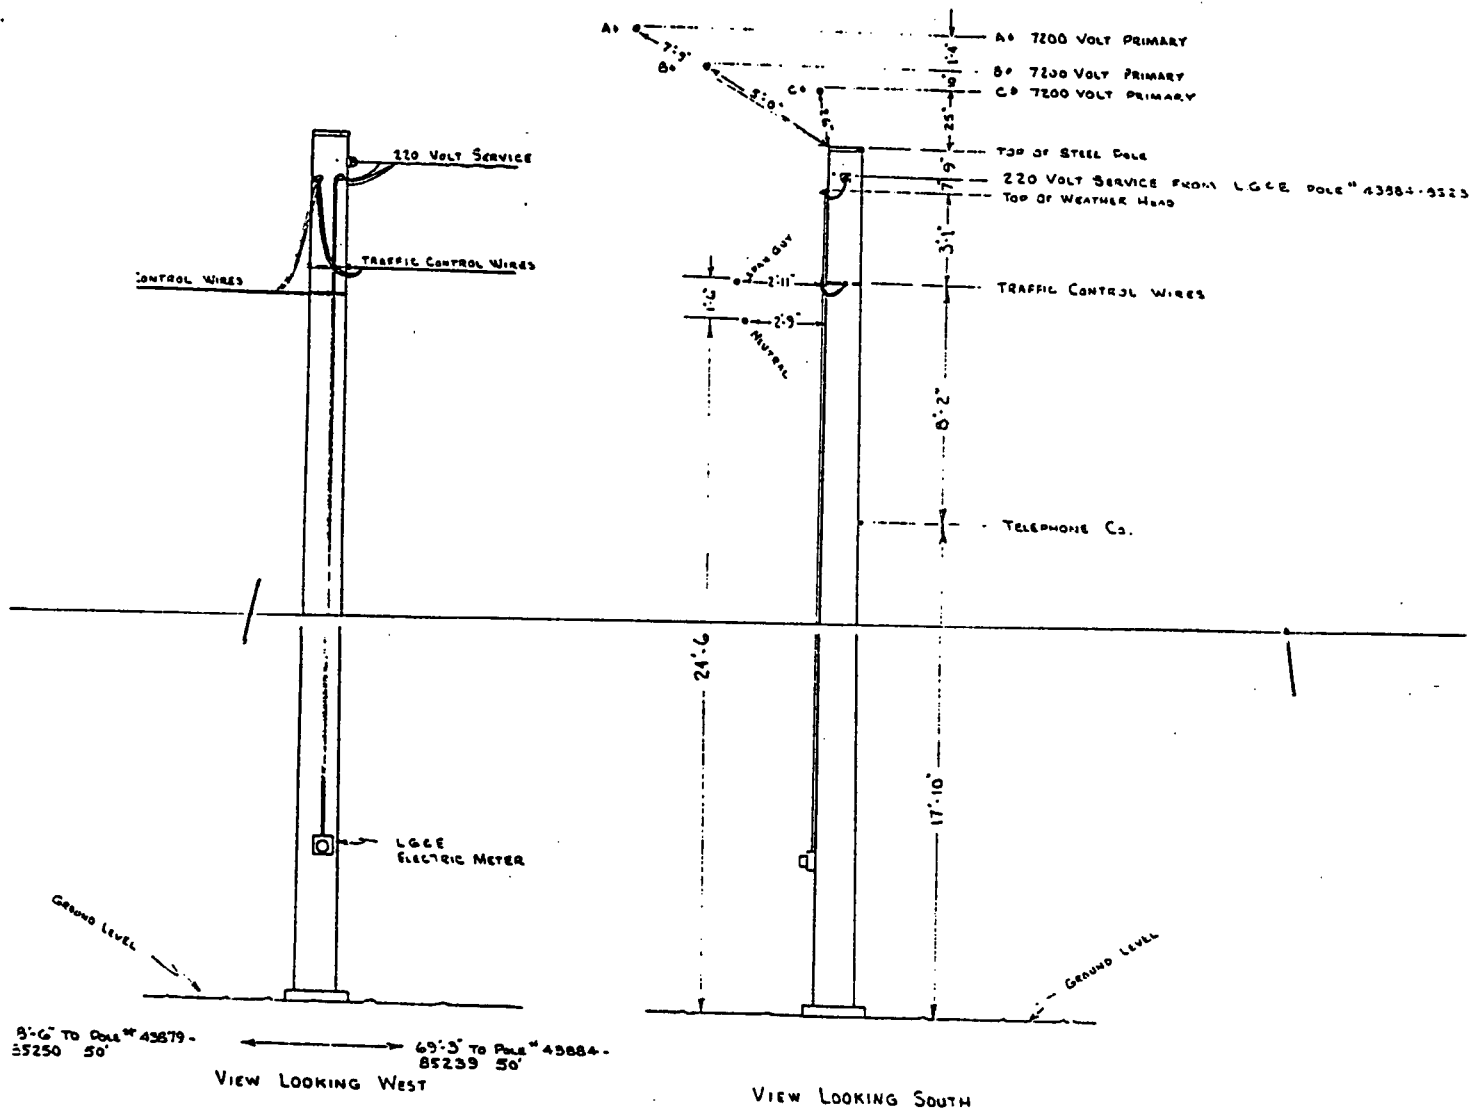
3. Commission Staff examined the accident scene and, specifically, measured the line clearances at the point of the accident. It was determined by measurement that the C-Phase conductor carrying 7.2 KV was 2 feet – 2 inches from the steel pole structure. NESC, Section 23, Rule 234B, 1&2, set a minimum clearance from phase conductor to structure of 4 feet – 6 inches. NESC standards are applicable to LG&E pursuant to 807 KAR 5:041, Section 3.

SKETCH SHOWING WEST VIEW  
 SOUTH VIEW OF STEEL TRAFFIC  
 CONTROL POLE NORTH/WEST  
 PRESTON HWY AND GILMORE  
 WHERE ACCIDENT OCCURRED  
 MITCHELL METZINGER 2-2  
 NO SCALE DRAWN BY G.W.
